Kildare-Meath Grid Upgrade Environmental Impact Assessment Report (EIAR)

Volume 3: Appendices

March 2024

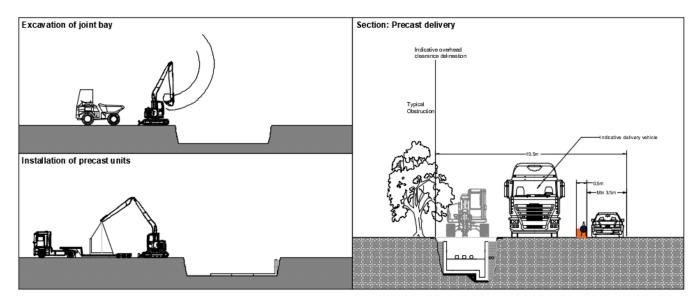
Figure 3-3 Joint Bay Construction (Sections)

Figure 3-3 shows the installation of the joint bay and the required construction space. A minimum 7.0m width of construction space would be required for the installation of the joint bays. This required 7.0m is calculated assuming the alignment of the joint bay with the road boundary. It will be noted that the delivery vehicle for the precast joint bay would only temporarily be in position for approximately two hours.

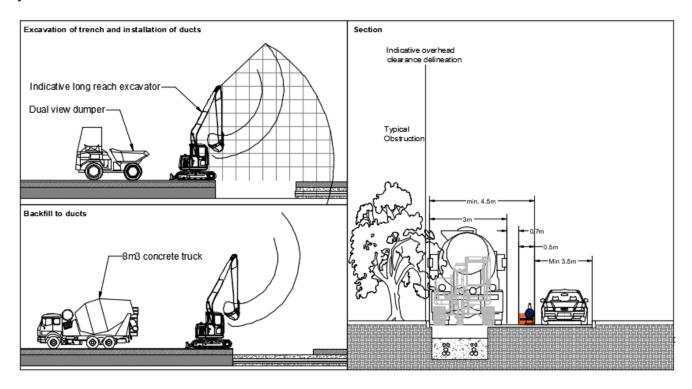
Figure 3-6 Duct Installation (Sections)

Figure 3-6 shows the construction space proofing for the installation of the ducts and the associated backfill. A minimum construction space width of 4.2m would be required. It will be noted this is considerably constrained and would likely result in reduced output.

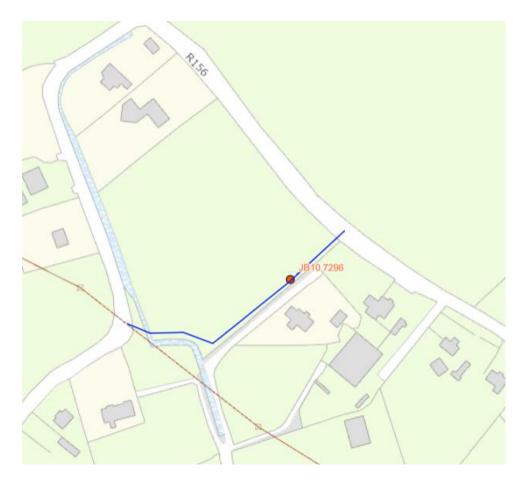
Figure 4-6 Section 1.03

Figure 4-6 shows the section from Mullagh to R125 North. This section is off-road and therefore the temporary traffic management is not required.

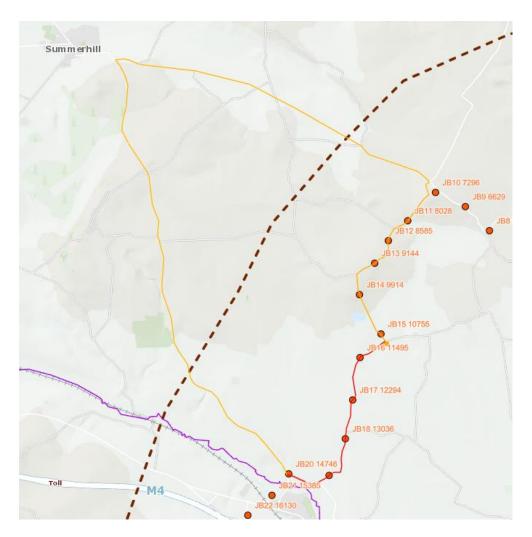
Figure 4-8 Section 1.05

Figure 4-8 shows the section from R125 South to R158. This in-road section is on a regional road and has 5no. joint bays along the alignment. There are no alternative diversion routes suitable during the works phase.

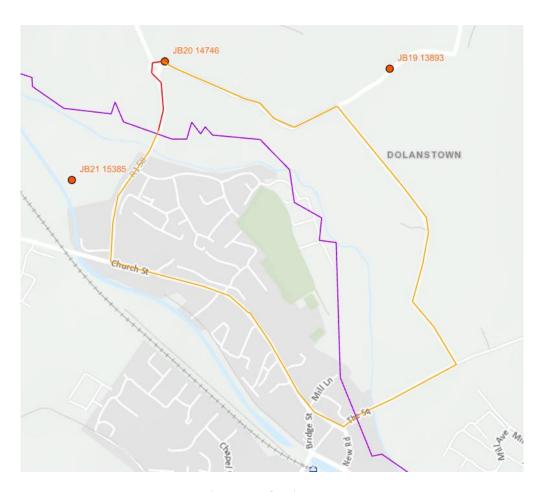
Figure 4-9 Section 1.06

Figure 4-9 shows the section from R158 to Balfeaghan. This in-road section is on a regional road and has no joint bays along the alignment. There are no alternative diversion routes suitable during the works phase.

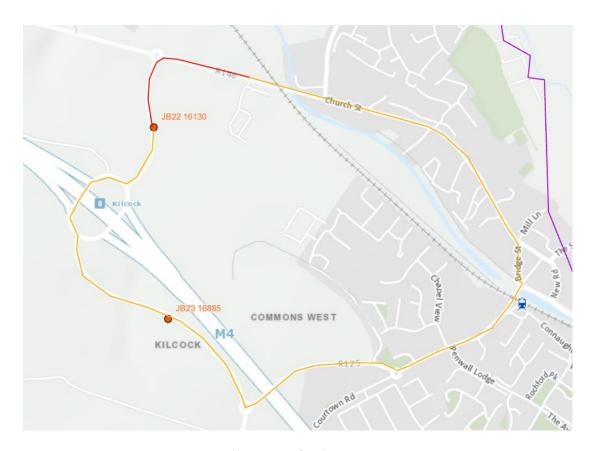
Figure 4-11 Section 1.08

Figure 4-11 shows the section from R148 to M4. This in-road section is on a regional road and has 1no. joint bay along the alignment. There are no alternative diversion routes suitable during the works phase.

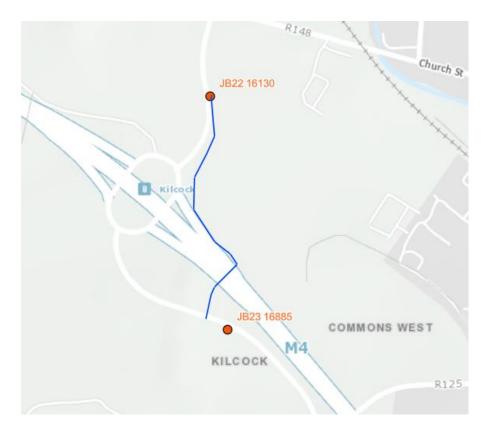
Figure 4-12 Section 1.09

Figure 4-12shows the section from M4 to R407 North. This section is off-road and therefore the temporary traffic management is not required.

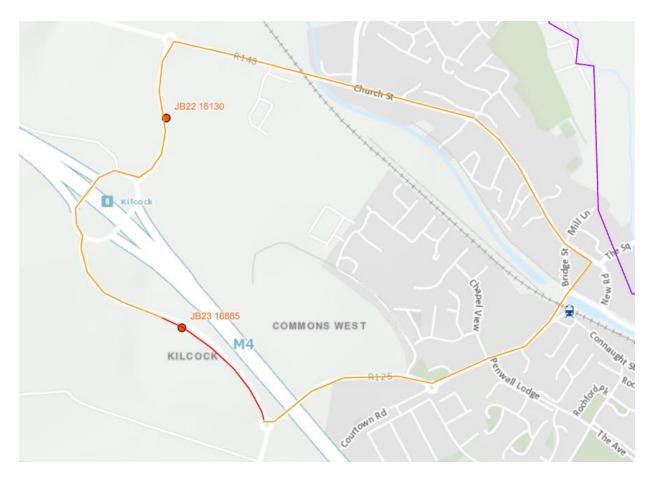
Figure 4-13 Section 1.10

Figure 4-13 shows the section from R407 North to R407. This in-road section is on a regional road and has 1no. joint bay along the alignment. There are no alternative diversion routes suitable during the works phase.

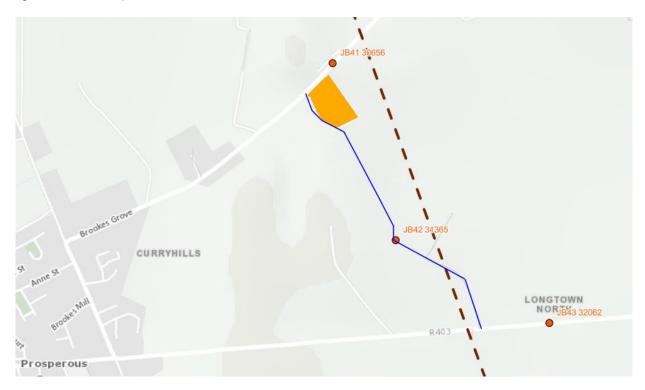
Figure 4-16 Section 1.13

Figure 4-16 shows the section from Curryhills to R403. This section is off-road and therefore the temporary traffic management is not required

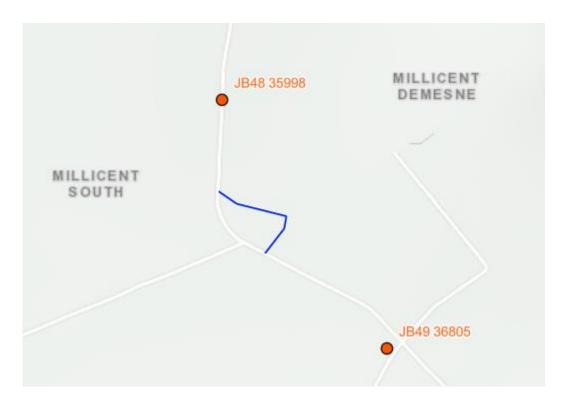
Figure 4-19 Section 1.16

Figure 4-19 shows the section from Millicent Demesne to L2002 South. This section is off-road and therefore the temporary traffic management is not required.

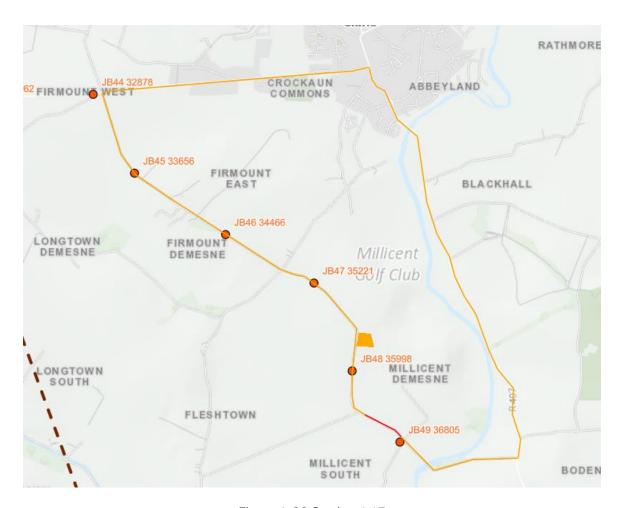
Figure 4-20 Section 1.17

Figure 4-20 shows the section from L2002 South to Castlesize. This in-road section is on a local road and has no joint bay along the alignment. There are no alternative diversion routes suitable during the works phase.

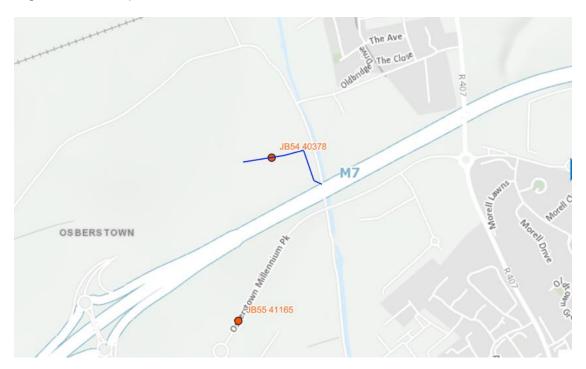
Figure 4-23 Section 1.20

Figure 4-23 shows the section from Mills to Osberstown Road. This section is off-road and therefore the temporary traffic management is not required.

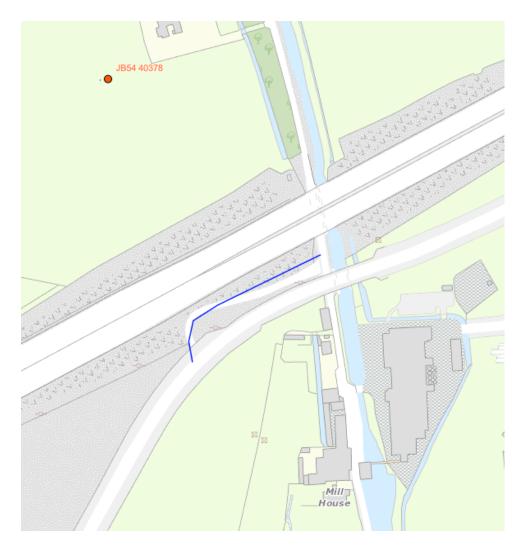
Figure 4-25 Section 1.22

Figure 4-25 shows the section from M7 to Millennium Parkway. This section is off-road and therefore the temporary traffic management is not required.

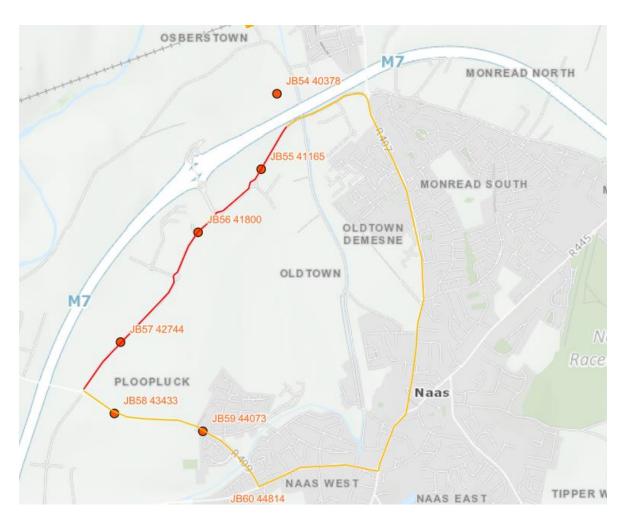
Figure 4-26 Section 1.23

Figure 4-26 shows the section from Millennium Parkway to R409. This in-road section is on a regional road and has 3no. joint bays along the alignment. There are no alternative diversion routes suitable during the works phase.

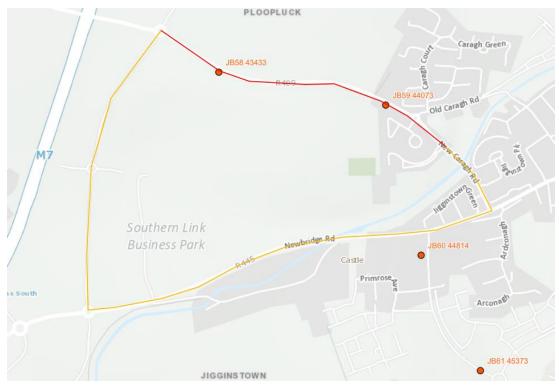
Figure 4-27 Section 1.24

Figure 4-27 shows the section from R409 to Grand Canal. This in-road section is on a regional road and has 2no. joint bays along the alignment. There are no alternative diversion routes suitable during the works phase.

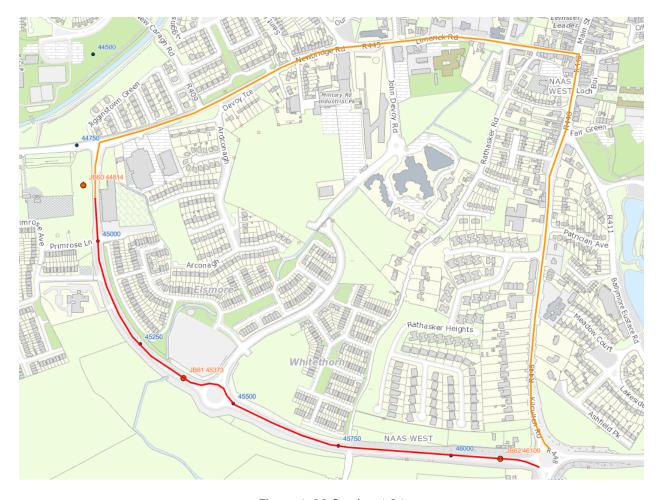
Figure 4-29 Section 1.26

Figure 4-29 shows the section from R447 to R448. This in-road section is on a regional road and has 2no. joint bays along the alignment. There are no alternative diversion routes suitable during the works phase.

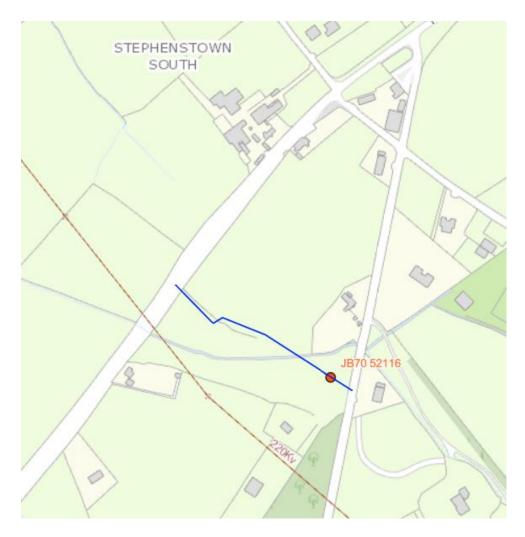
Figure 4-32 Section 1.29

Figure 4-32 shows the section from Stephenstown to R412. This section is off-road and therefore the temporary traffic management is not required.

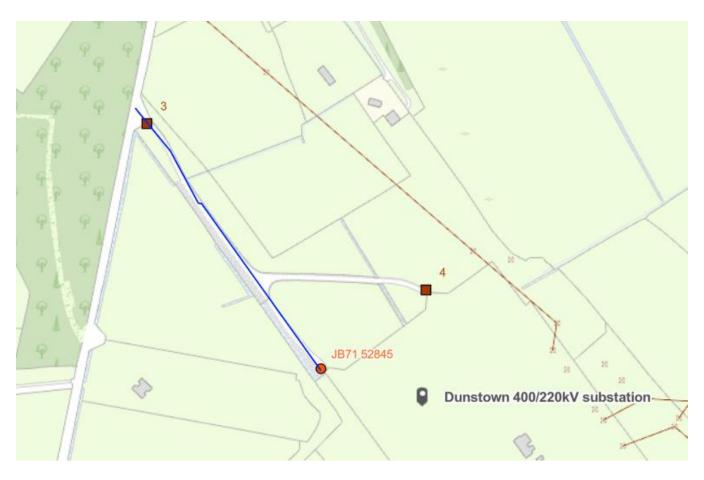
Figure 4-34 Section 1.31

Figure 4-34 shows the section from Dunstown to Dunstown Substation. This section is off-road and therefore the temporary traffic management is not required.

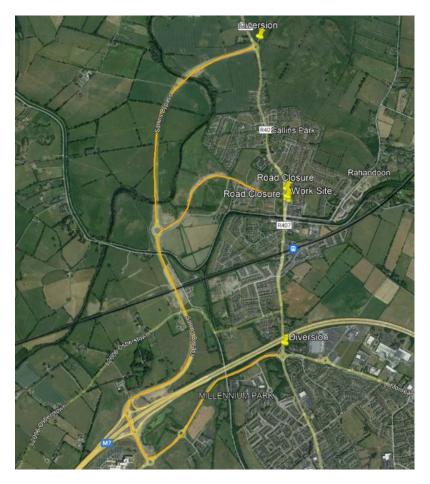
Figure 5-1 Utilities location and diversion

Figure 5-1 shows the location of the works with the required road closure and associated diversion route. The contractor had agreed with the local council to close the road to enable the delivery of this project safely.

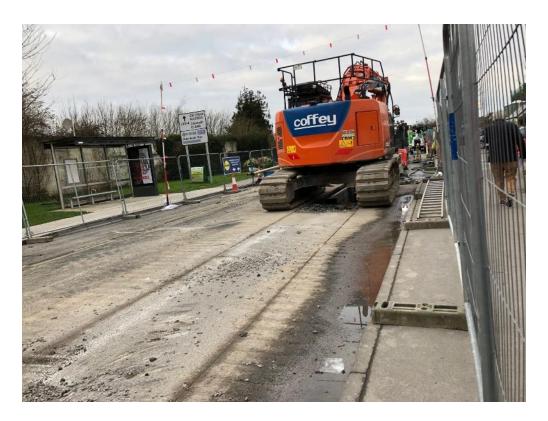
Figure 5-2 Preparation for removal of wearing course

Figure 5-2 shows the preparation required to remove the wearing course from the road surface. This utilised saw cuts in the road to the width of the trench width. The size of the machine enabled the excavator to site its tracks either side of the trench to allow for the breaking out of the road surface.

With the site setup shown there is enough space to position a tipper wagon adjacent to the excavator which can only be achieved with full road closures. However, when lane closures are employed then the tipper wagon would need to be positioned behind the excavator and provision will need to be made for the arm and bucket of the excavator to swing round 180 degrees. This will mean that time needs to be built into the traffic signals to allow a clear space in traffic, reducing the efficiency of the excavation time and increasing the manpower on site to watch for the traffic to be out of the hazard zone.

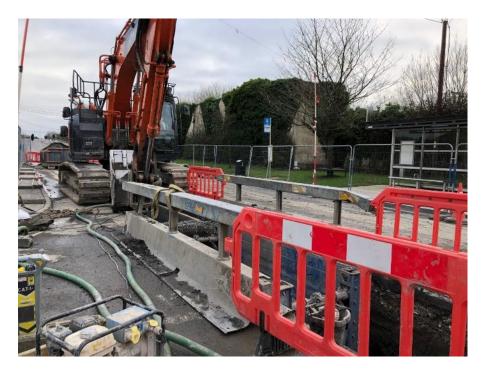
Figure 5-3 Excavation with trench box support

Figure 5-3 and Figure 5-4 show the use of trench boxes to safeguard operatives working in the trench. A singular trench box is used and follows a drag box style of work. Note the requirement for pumping in the excavation, it was unclear if this was high ground water, seepage or run-off driven.

The use of trench boxes or alternative ground retention methods would be is dictated by the makeup of the ground. It is likely that these type of trench boxes may also be required for the Proposed Development, but this are dependent on the ground conditions and suitable temporary works assessments by the contractor.

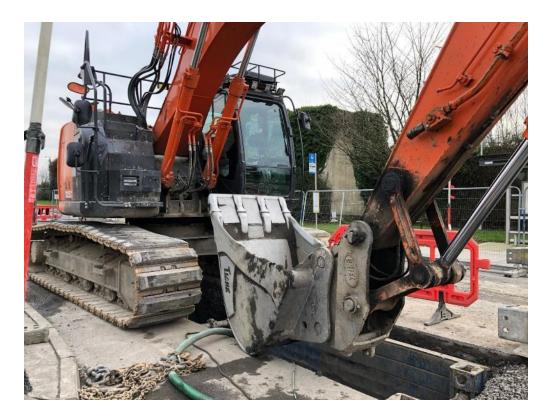
Figure 5-5 22t excavator

Figure 5-5 shows the excavator bucket width is the same as that of the trench. The removes the requirement for the excavator to move position to dig the width of the trench. In comparison to the proposed scheme, a 2.1m width bucket is available, however this could potentially require a suitably sized machine, in turn increasing the working width and increasing the amount of road closures.

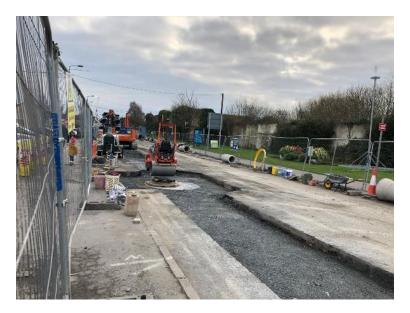
Figure 5-6 Resurfacing and backfill

Figure 5-6 shows the completed backfill works completed to underside of the wearing course. Ironmongery is visible in this figure. It is evident that upon completion of the section, the wearing course will be installed in one operation.

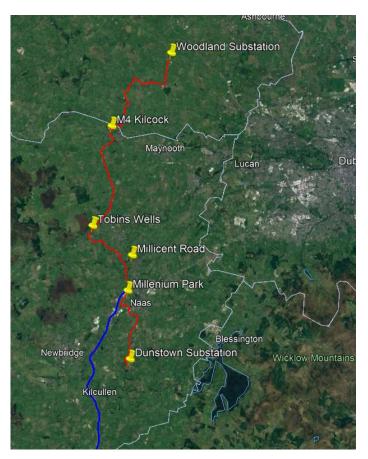
Figure 3-3 Proposed Compound Locations

Figure 3-3 shows proposed compound locations, each compound would be recommended to be positioned near a key logistical corridor, i.e. N and M roads. The compound at M4 Kilcock would be suitable for both cable logistics and the proposed HDD. An additional compound has been shown in the Millicent area due to the complexity associated with the local area.

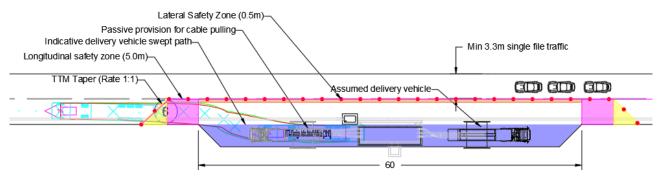
Figure 2-3 Off-road joint bay

Figure 2-3 shows the required construction passing bay for off-road or 'in-verge' joint bays. To ensure the safety and stability of all construction vehicles, a platform will be provided to be designed and constructed. Without a suitably designed construction platform this could present difficulties installing the cable and further health and safety issues, including vehicles instability, lack of traction, over-turning or utility damage. The proposed passing bay is based on the ESB issued passing bay drawing (229100428-MMD-00-XX-DR-E-4119 Rev PL1).

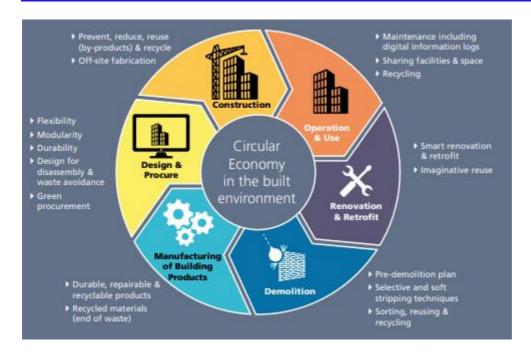
The principal objective of sustainable resource and waste management is improving the efficiency of resource use, i.e. maintaining the value of materials and resources within the economy for as long as possible, minimising the generation of waste. This model is referred to as the Circular Economy model, where materials or resources are continually reused within the economy, through straight reuse, repair, redistribution, refurbishment or remanufacture. This differs from the traditional linear model of produce, consume, and discard. The circular economy is illustrated in Image 1.2.

Image 1.2: Circular Economy Model (taken from the EPA WMP Guidance Figure 2-1)

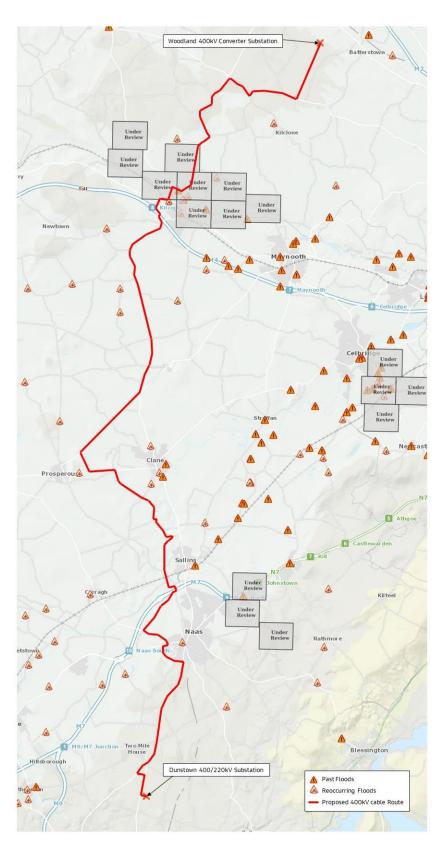
Indicatively, there is a record of a past flood occurring near Kilcock on 18/08/2008. The linked report contains images of localised floods occurring around the River Rye, which the Proposed Development crosses. Fields around the area and part of the highway are shown partially flooded after a bout of prolonged heavy rain. A summary of the effects from reoccurring floods along the path of the Proposed Development can be found in the meeting minutes of an OPW Flood Hazard Map meeting with the local Engineer reporter for Clane.

Figure 4.1 Extract of past flood events near the Proposed Development route. Source: OPW National Flood Hazard Mapping website (www.floodinfo.ie)

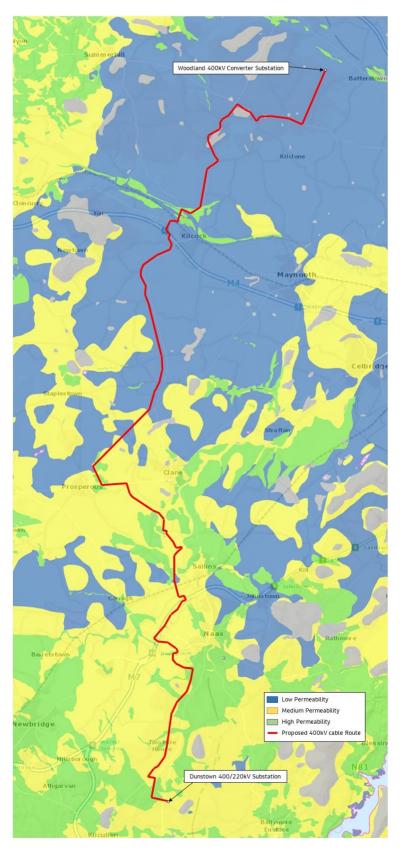
Figure 4.15 Extract of subsoil permeability mapping from the GSI Groundwater Data Viewer mapping at the Proposed Development and surrounding area.

Regarding potential seepage of groundwater into the proposed open cut trenching during construction, existing groundwater protection scheme reports for County Meath and Kildare reveal no significant shallow deposits of groundwater in the area of the Proposed Development. Local borehole testing would reveal the water table level and any potential seepage. However, Geological Survey Ireland (GSI) maps reveal soil permeability along the Proposed Development. As shown in Figure 4.15, soil permeability is generally "Low" around the north end of the development, transitioning into "Medium" around Prosperous and Clane, and local crossings with "High" permeability areas west of Sallins and south of Naas.

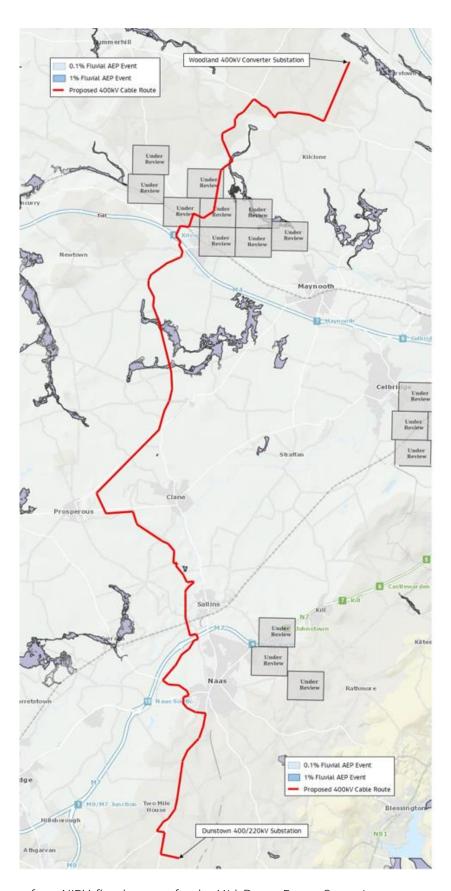
Figure 5.5 Extract from NIFM flood extents for the Mid-Range Future Scenario.

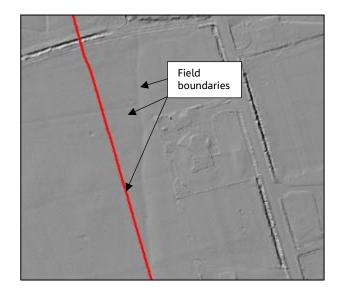
Figure 19: Linear and curvilinear features in Baltracey interpreted as former field boundaries forming small and irregular fields that comprise a field system of unknown date (LI_097) (extends east beyond the 100m Study Area; red line). Cultivation patterns as well as a possible trackway were also noted.
